Environmental and Social Impact Assessment for the Regional Solid Waste Management Facility (RSWMF) Thilafushi

Marine Survey Report

23rd September 2019

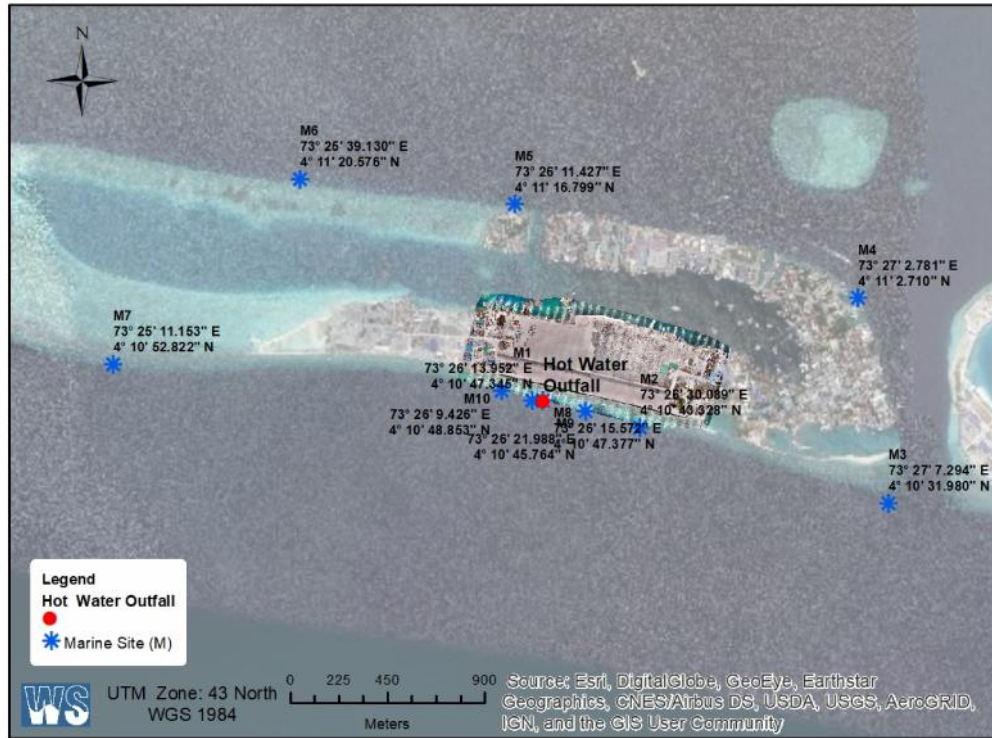
Figure 1: Marine surveyed locations with coordinates in 23rd – 24th April 2018 and 1st September 2019

The marine benthic and fish surveys at Thilafushi Island was focused on 10 sites. Plankton tows and water samples were done at 7 sites on 23rd – 24th April 2018. Marine surveys were done at marine sites M1 to M7 on 23rd – 24th April 2018. Three sites, M8 to M10 were surveyed on 1st September 2019 as more detail marine survey was requested to locate the hot water discharge location on southern side of Thilafushi. These three sites were chosen within a 500 m zone on the southern side of Thilafushi as shown in Figure 3. M8 was one of the potential site to locate the hot water discharge outfall.
